Comments from Imtac about proposals for a public realm scheme in Hillsborough village

(December 2024)

This report has been written following a request from Lisburn & Castlereagh City Council to review proposals for a public realm scheme in Hillsborough village. The report covers parts of Ballynahinch Street, Lisburn Street and Dromore Street as well as the entirety of Main Street, Park Lane and Park Street.

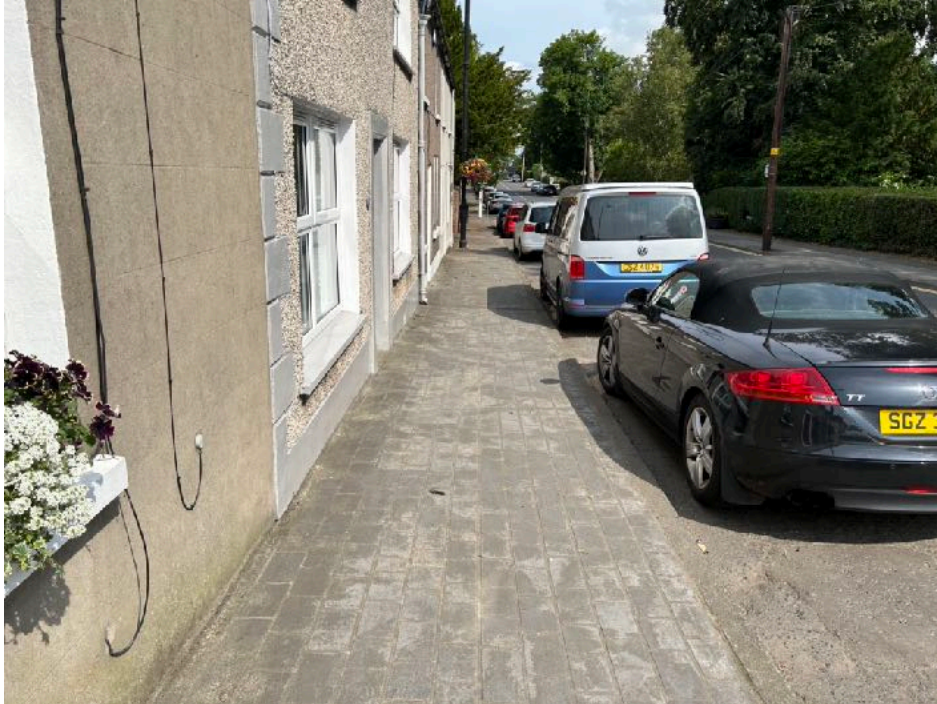
Lisburn Street is characterised by narrow footways (which fall below minimum acceptable standards in places) on both sides with on street parking on the western side. There is constant heavy traffic on the street.

There are still places in the village where footways will be unacceptably narrow. The Committee recognises that the building line and restrictions with carriageway width means that little can be done to address the very narrow footway on Lisburn Street. The Committee recommends that an uncontrolled crossing be provided across Lisburn Street to provide a barrier free alternative route for pedestrians.

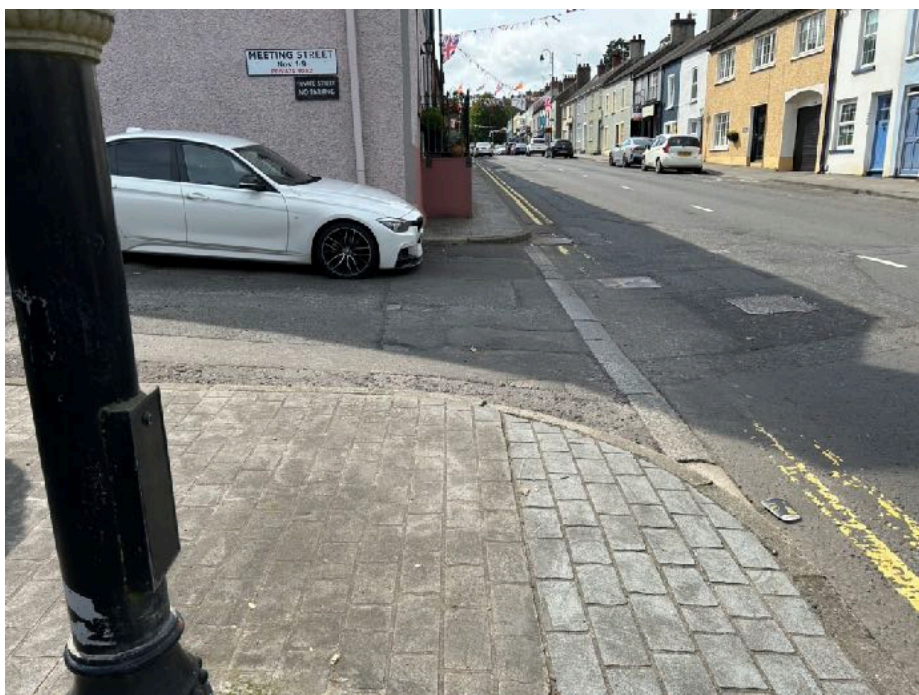
The street has an irregular building line with steps into houses narrowing the footway to unacceptable levels in places.

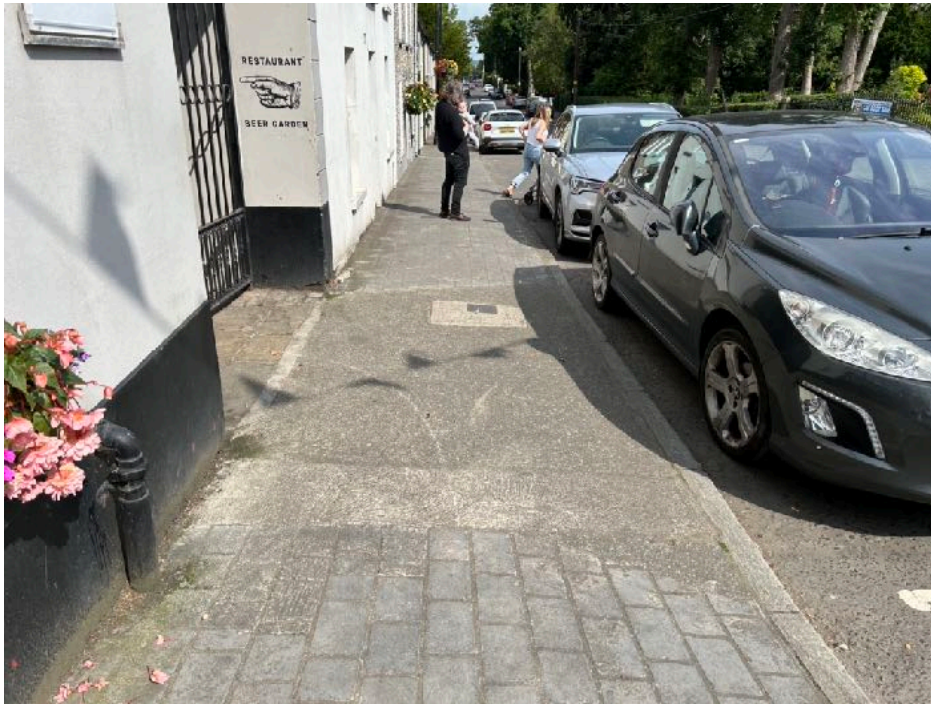
There are frequent vehicle entrances along the length of the street which are in use and these create potential hazards for people walking and wheeling.

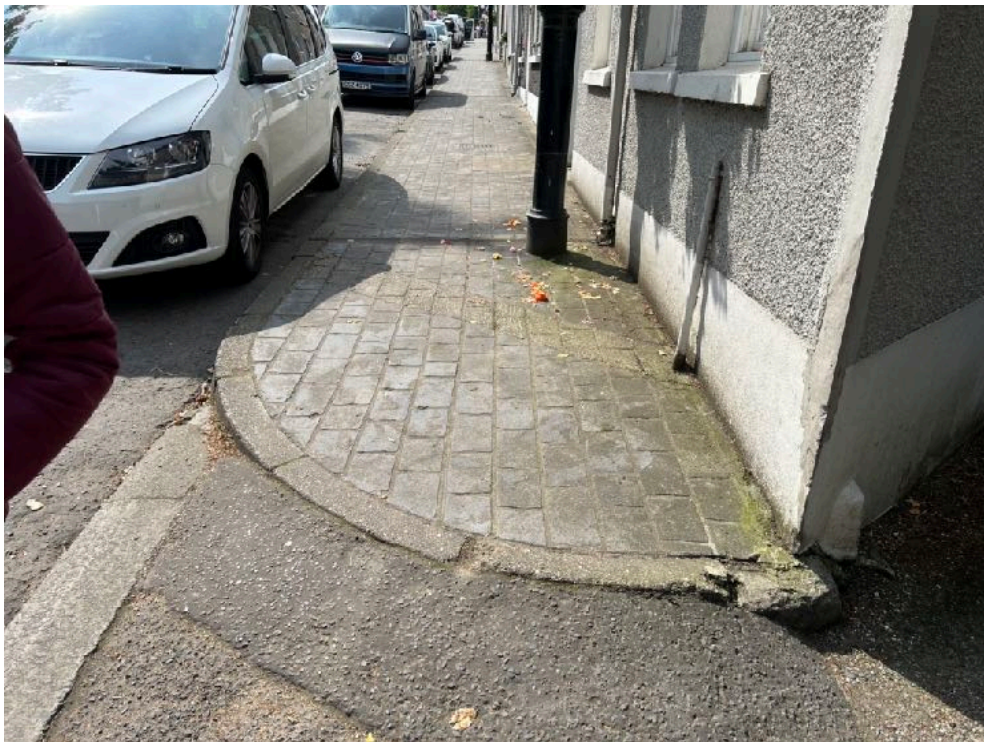
The condition of the footway at some vehicle entrances is poor in places.

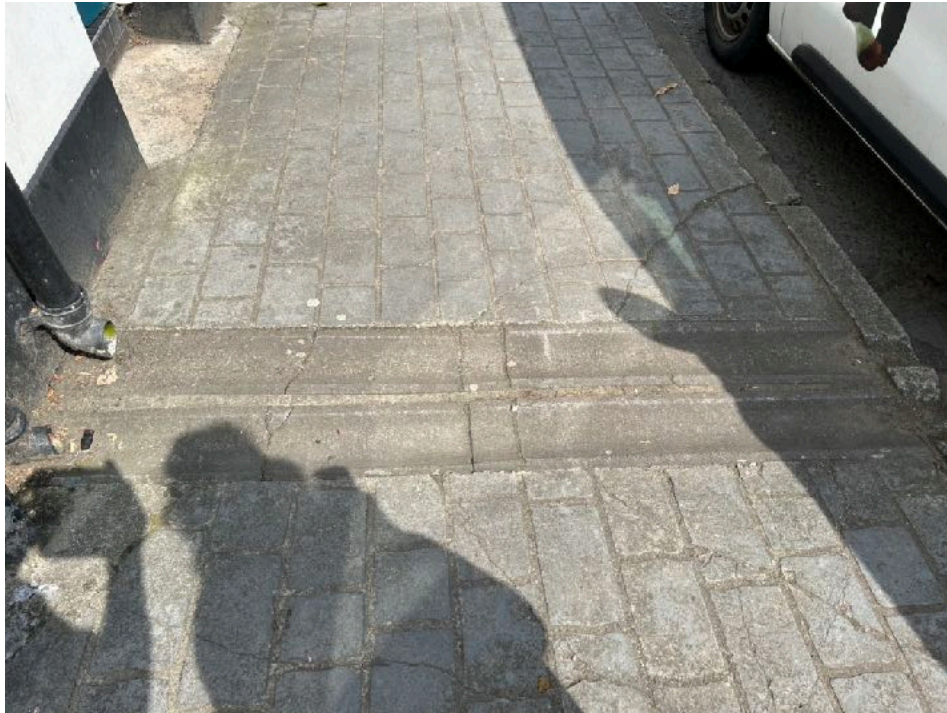
The wider condition of the footway is mostly satisfactory, although the use of dish drainage channels impacts on the comfort of the footway for some users.

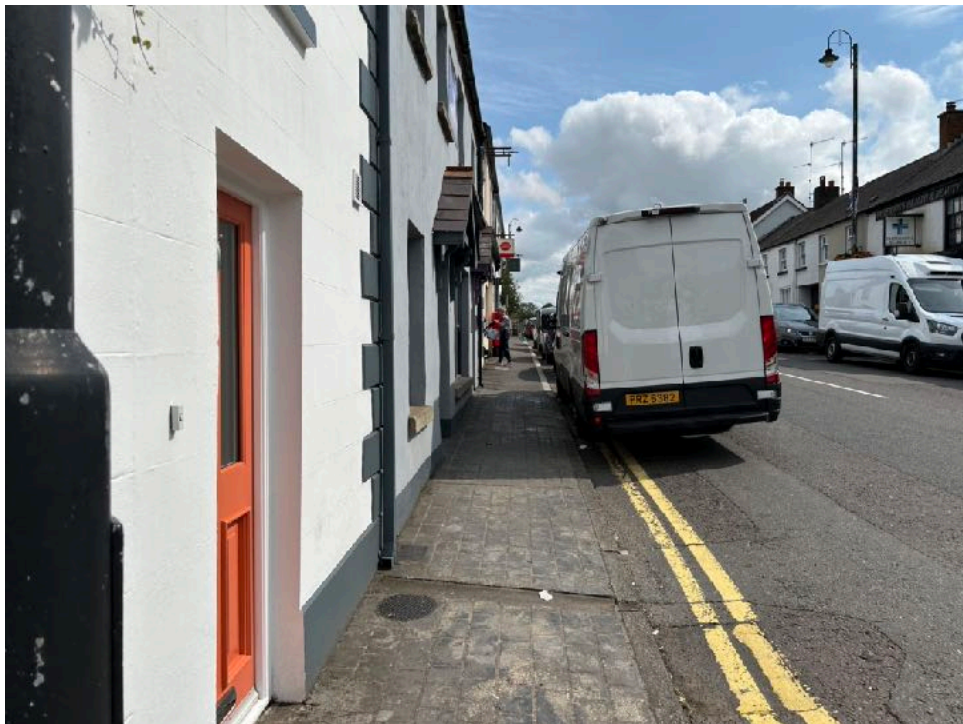
Ballynahinch Street is characterized by narrow footways and on street parking on both sides. There is constant heavy traffic on the street.

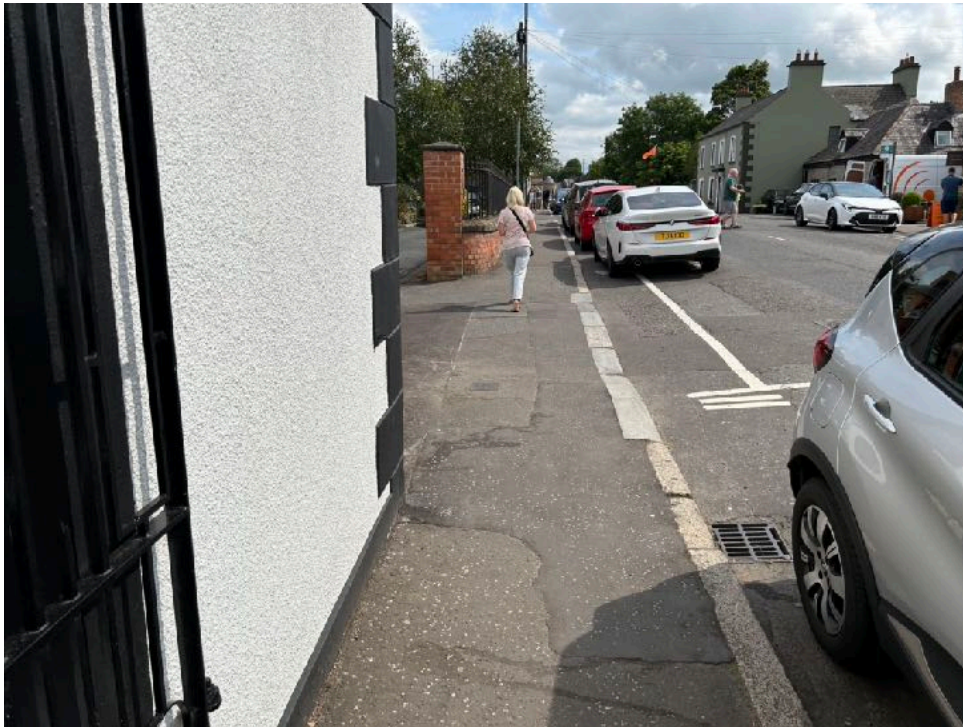
There are several vehicle entrances along the northern footway that are a potential conflict between vehicles and people walking and wheeling.

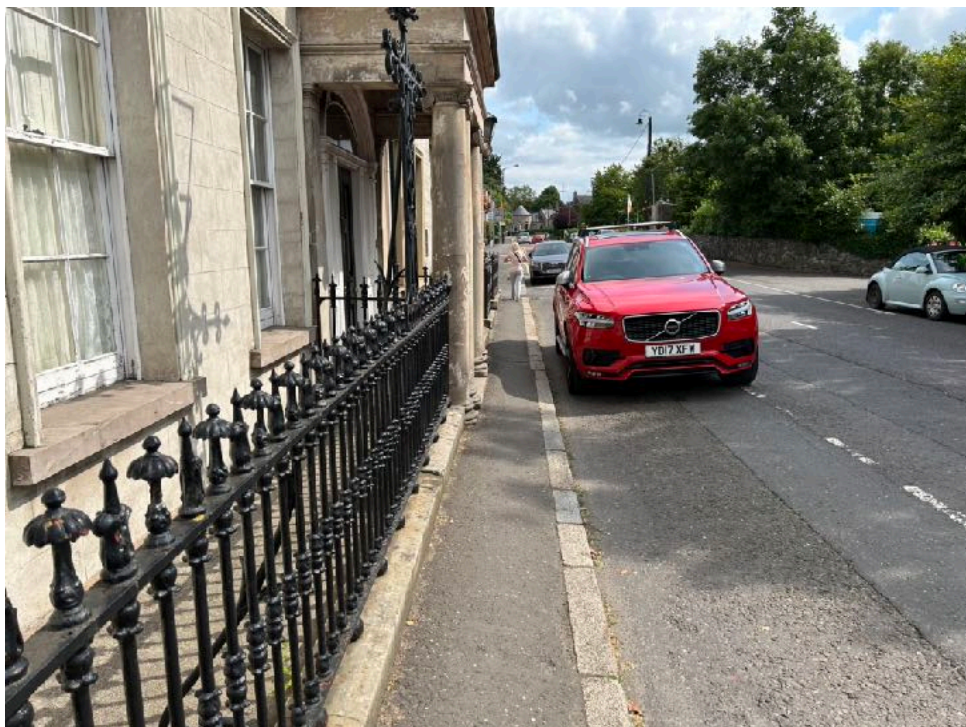
The northern footway narrows to an unacceptable level because of the extended building line of the old bank.

Currently it is proposed to exclude the narrow footway around the old bank building on Ballynahinch Street from the scheme as removing parking to widen the footway is deemed too controversial. Imtac believes that leaving an inaccessible footway is unacceptable when investing in public realm and recommends that the footway be widened at the expense of several parking bays. This will benefit more people than it will di24sbenefit.

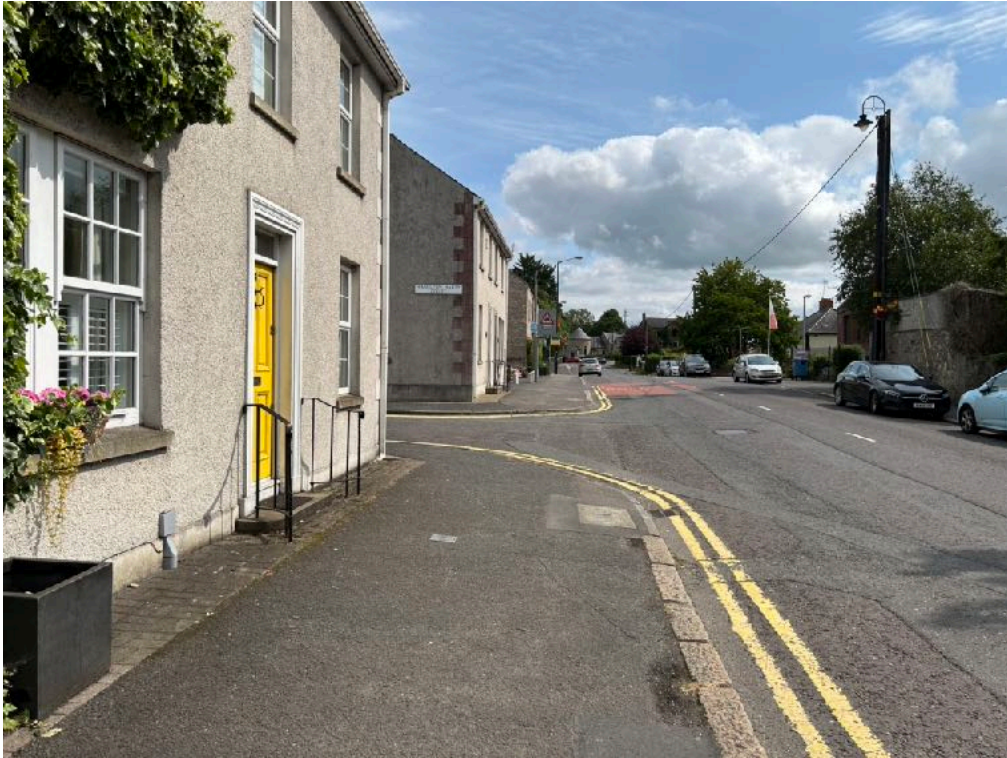
There is no safe and accessible crossing across the junction with Hamilton Harty Court.

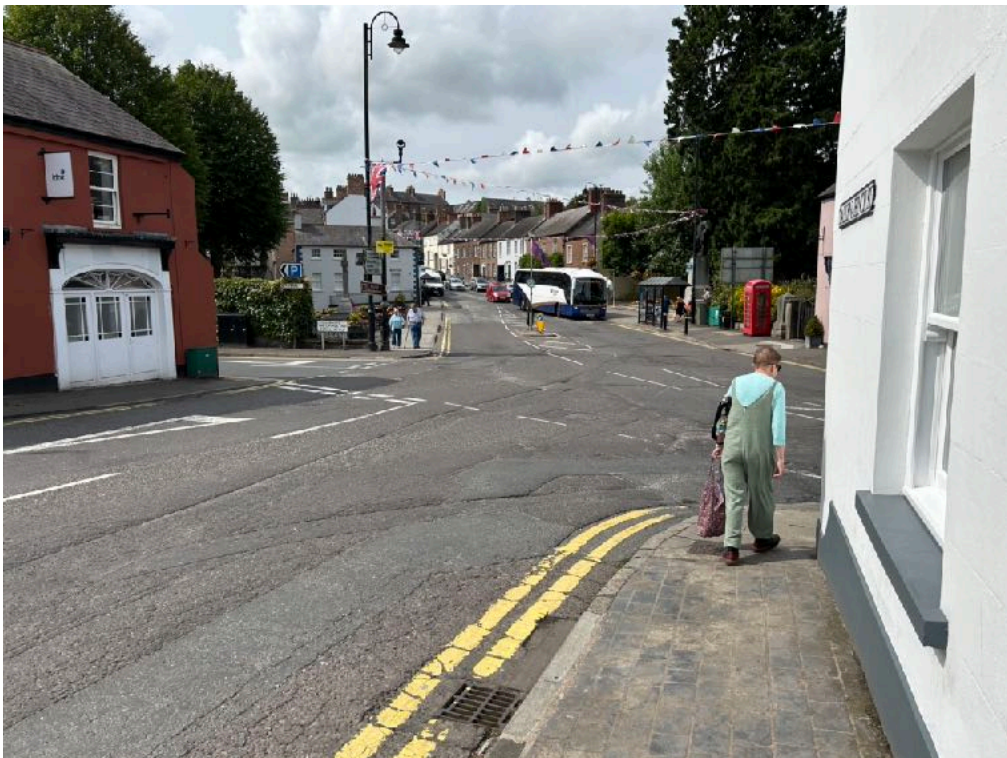
Generally, there is no safe and accessible crossing across Ballynahinch Street.

Crossings will remain an issue throughout the village with no proposed crossing on either Lisburn Street or Ballynahinch Street. This makes it exceptionally difficult for disabled people and older people to move around the village. Imtac recommends that accessible crossing opportunities be provided on both streets.

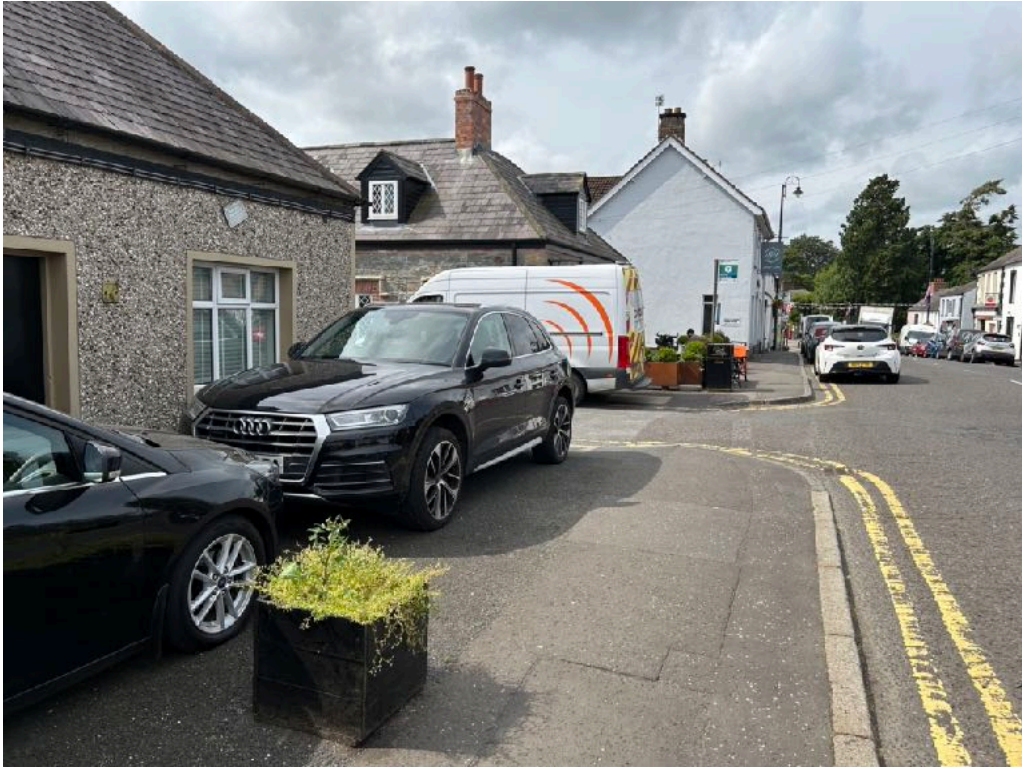
There are bus stops on either side of Ballynahinch Street. However, no provision has been made to ensure buses can access the kerb, rendering these services inaccessible to some potential users.

Buses using the bus stops on Ballynahinch Street cannot currently access the kerb and therefore are not accessible to some disabled people. Imtac recommends that bus stops on the street have kerb access, using build outs if necessary.

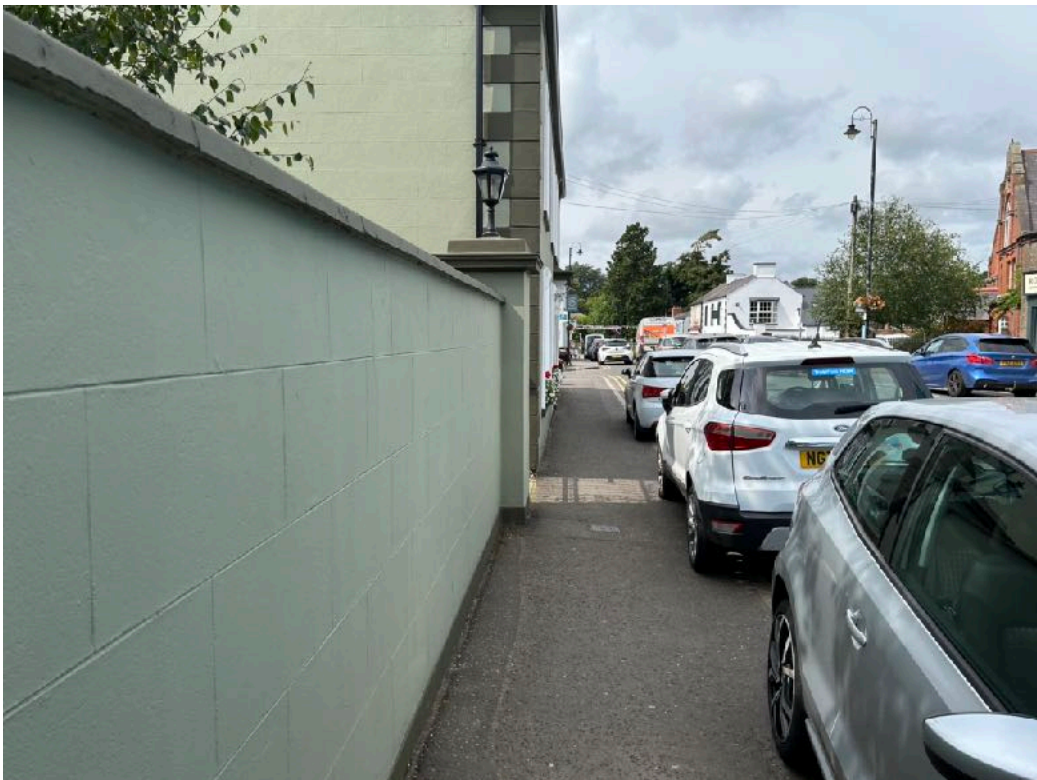
Parking on the pavement obstructs people walking and wheeling on the southern footway.

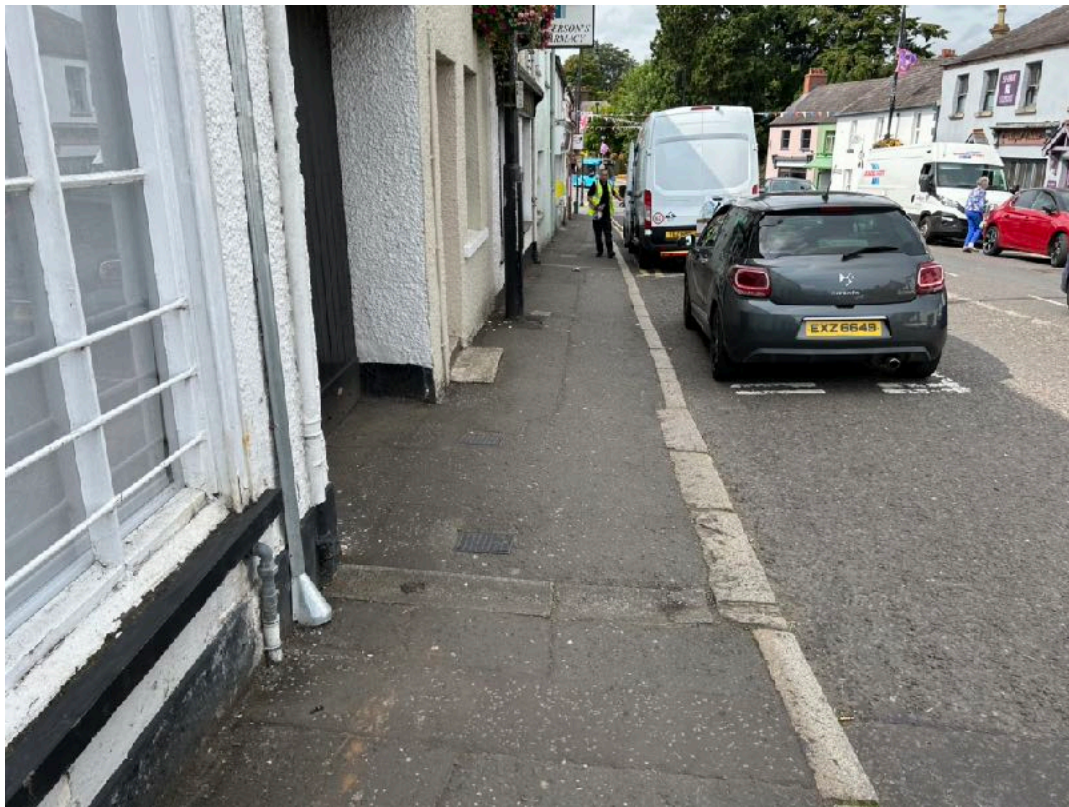
In use vehicle entrances are an issue on this footway too.

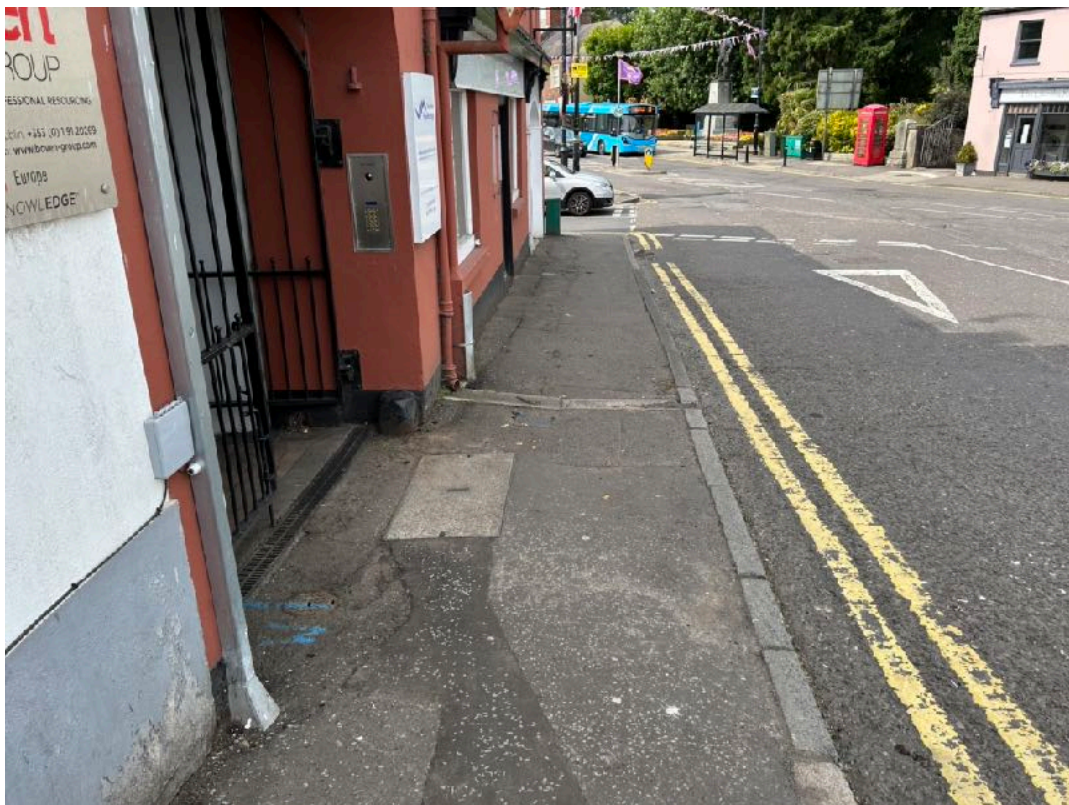
Footway conditions are poor in places along the southern footway and the use of dish drainage channels on both sides impacts on pedestrian comfort and accessibility.

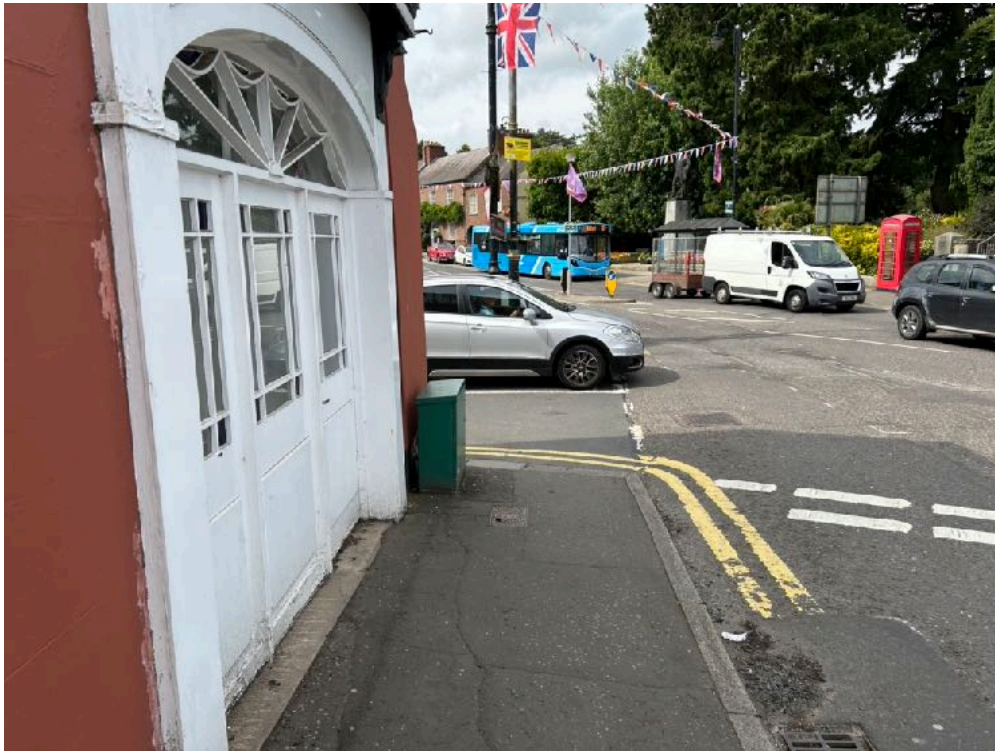
The junction where the three streets meet is exceptionally busy with heavy and constant traffic. This is not a safe place for people walking and wheeling.

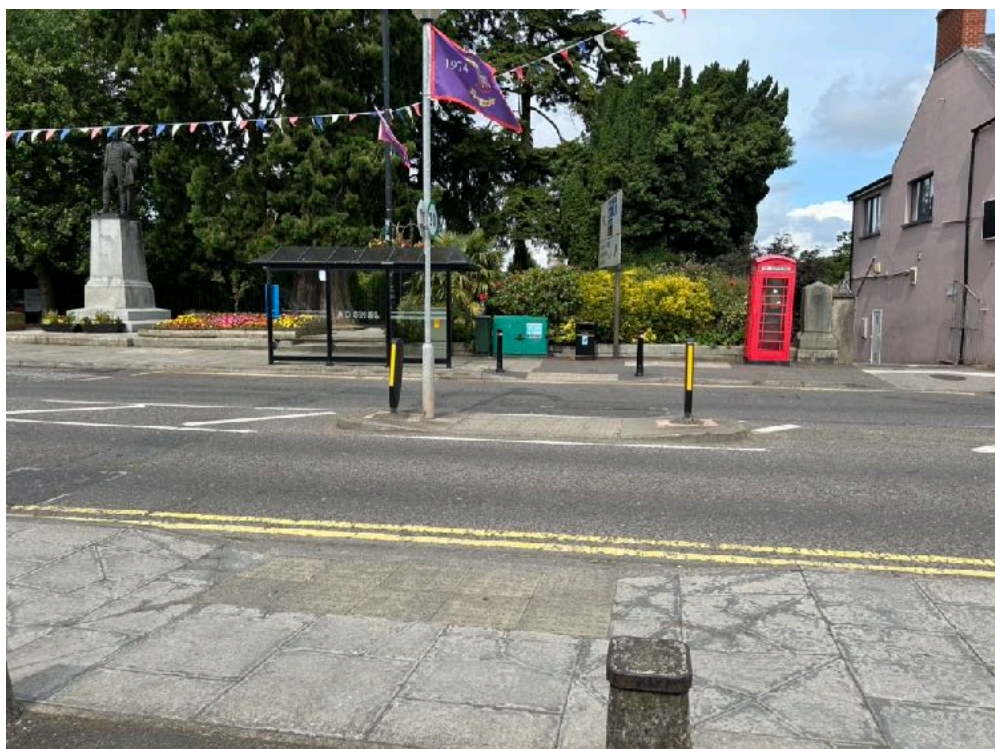
Crossing the street here is only possible via an uncontrolled crossing on Main Street which has a traffic island at it's mid point. This crossing is extremely challenging for some people to use independently.

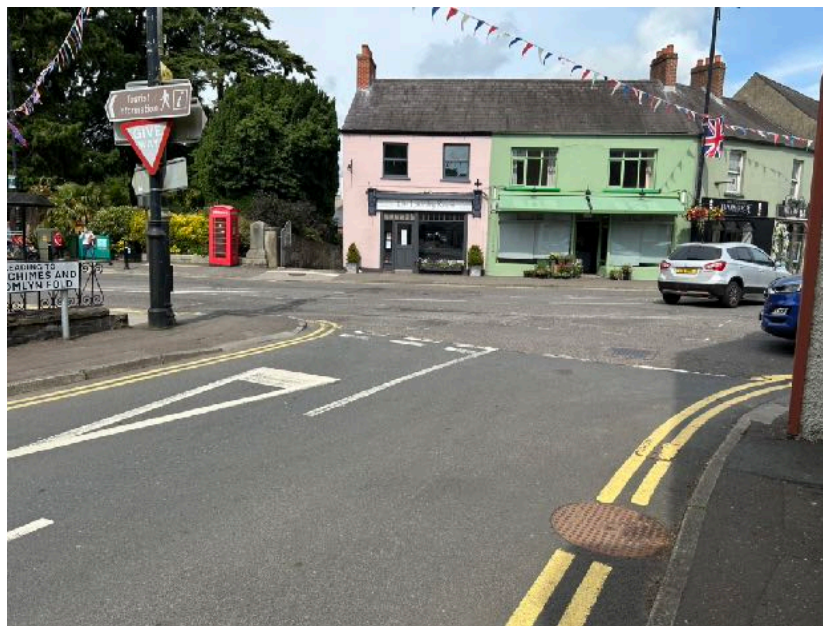
The public car park entrance on the east side of this junction adds to the challenges for pedestrians in this area. The current layout for pedestrians at this entrance is confusing and inaccessible.

Safe pedestrian access to Main Street to and from the car park is only possible currently on the church side of the footpath. Access here is very limited and does not meet inclusive design standards. (See image above)

People walking and wheeling from Ballynahinch Street have to step on to the carriageway to access the footway to the car park before crossing the access road again when the footway peters out.

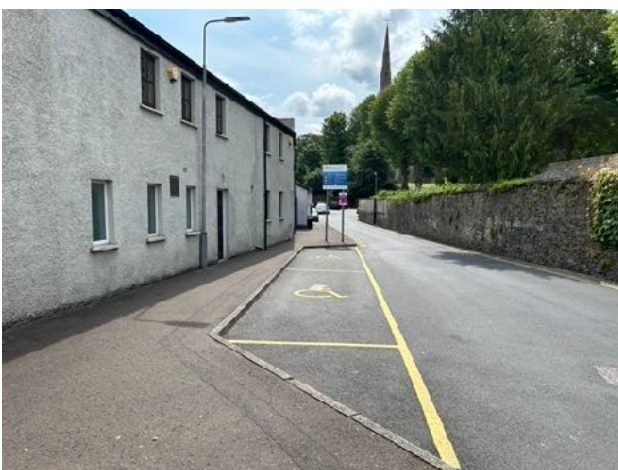
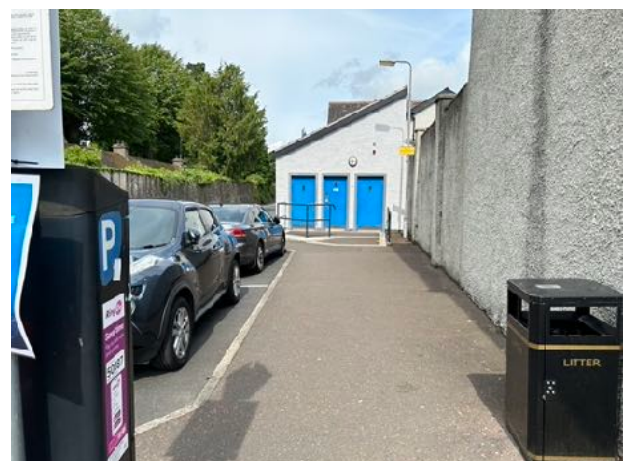
The car park contains accessible parking and public toilets including an accessible toilet.

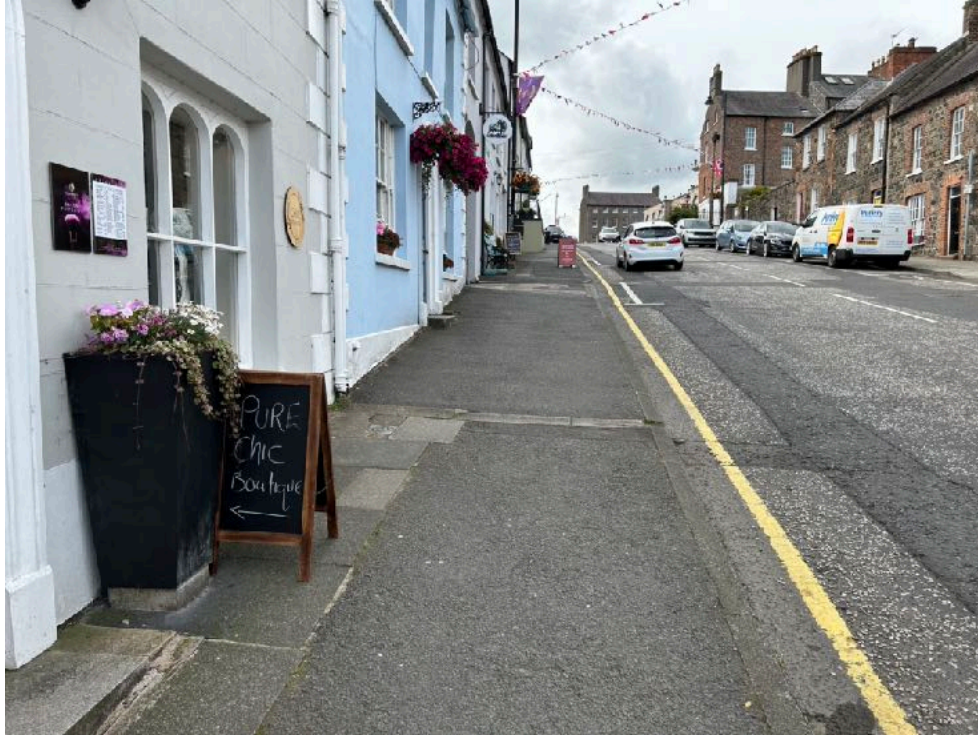
Main Street is characterised by its steep gradient. On street parking is available on the western side of the street. There is constant heavy traffic on the street.

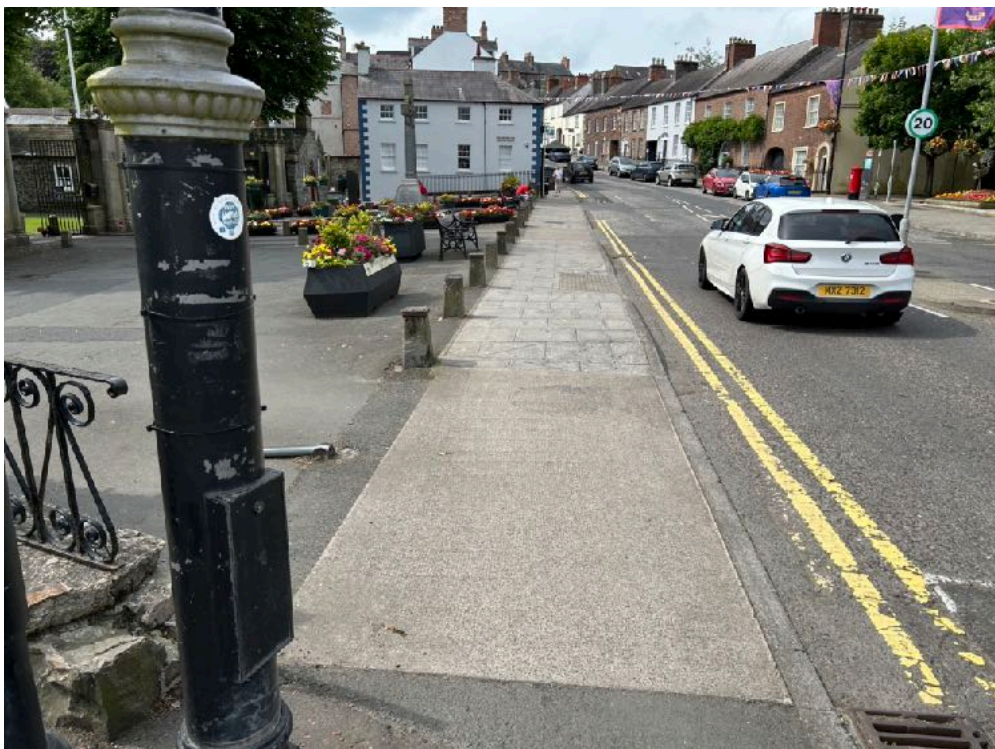
The area around the church contains vehicle entrances but also some seating, the uncontrolled crossing across Main Street and a bus stop with shelter and bus cage to prioritize bus access close to the kerb.

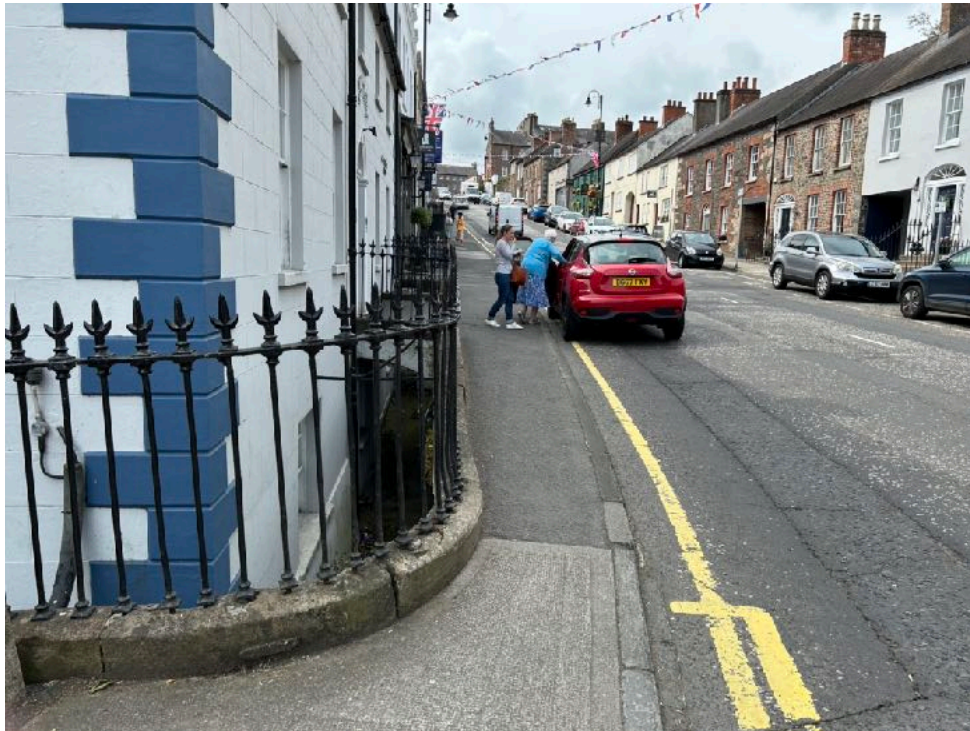
The building line reduces the east side footway width to unacceptable levels just after the church. After this point the footway broadens out.

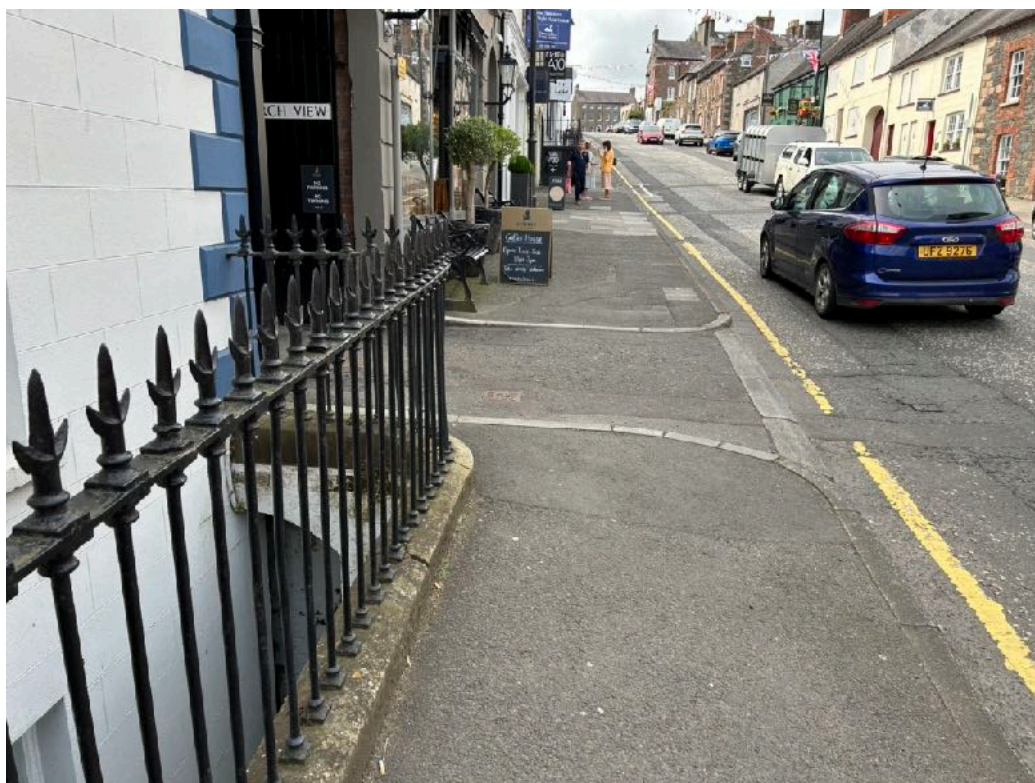
There are a significant number of vehicle entrances along both footways on main street, representing potential conflict points between vehicles and people walking and wheeling.

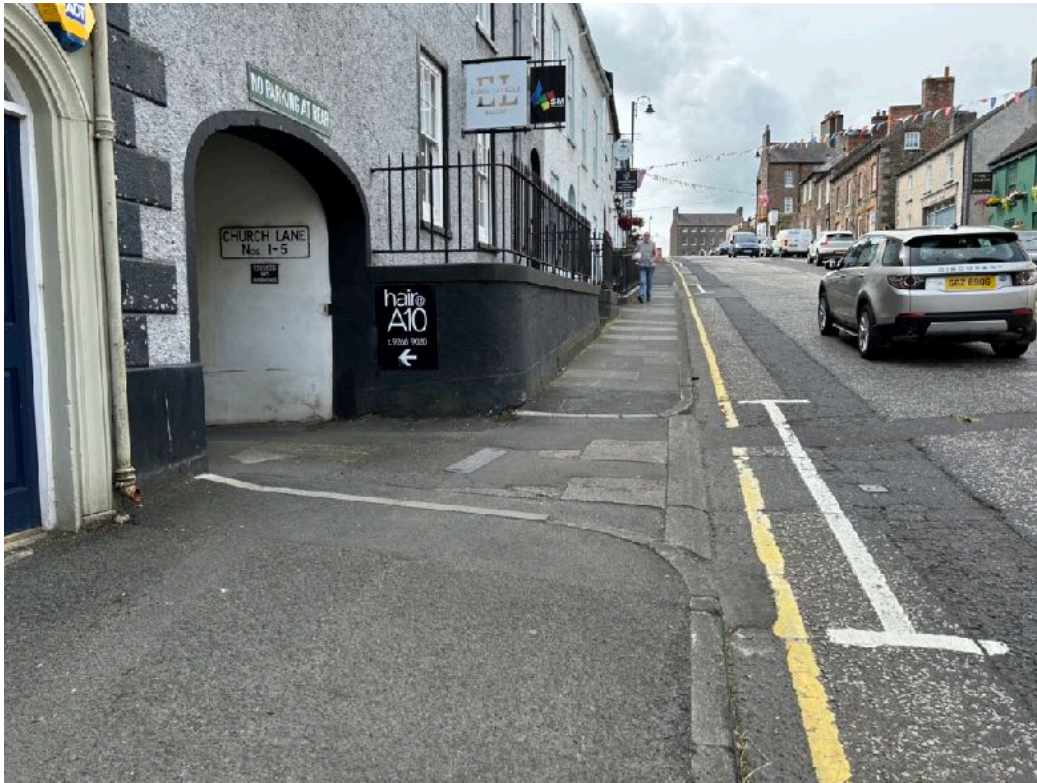
Footway condition is poor in places, particularly around vehicle entrances. Although for the most part step free access is facilitated, the steep gradient of the street has made provision less than ideal in places.

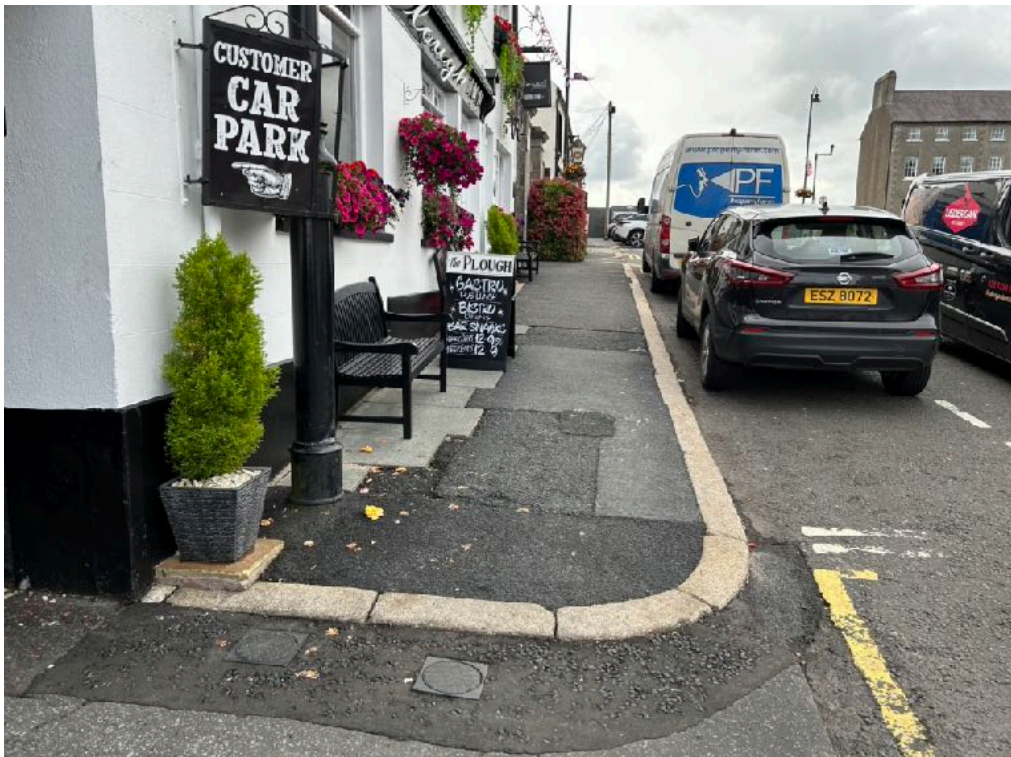
Street furniture and other clutter including floral displays restrict footway width in places along Main Street.

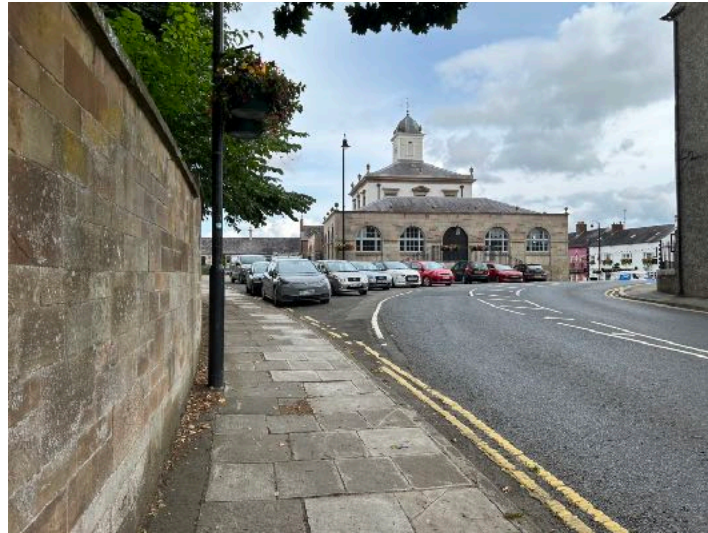
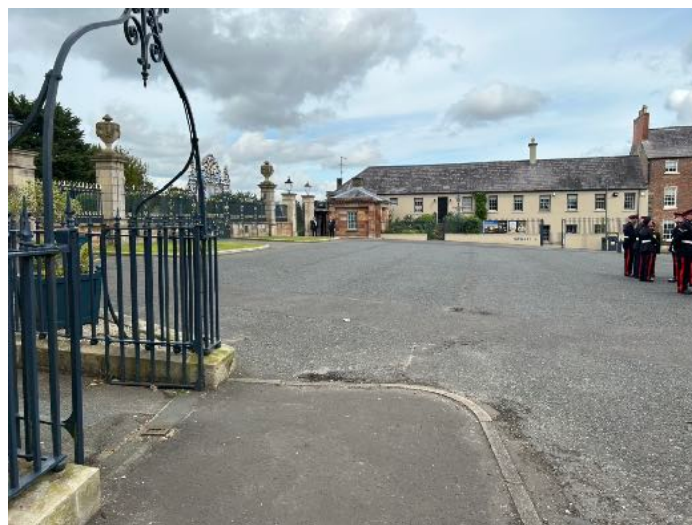
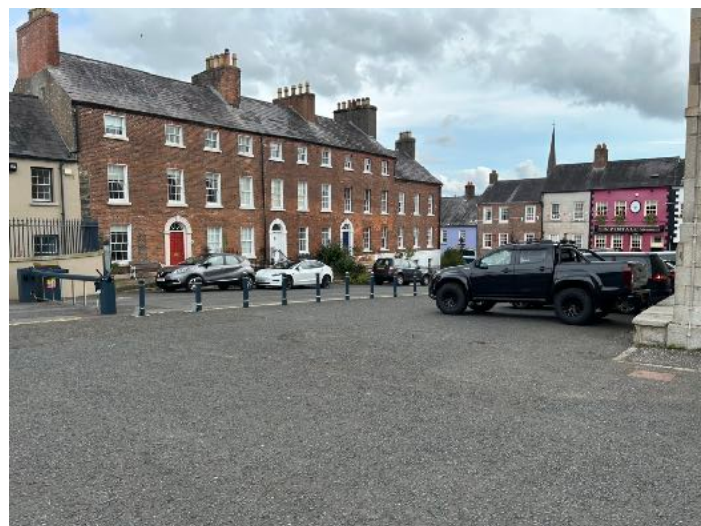
The area around the Square is particularly problematic from an accessibility perspective. The existing footways on Main Street and Dromore Road terminate at the Square and there is no segregated step free pedestrian route around the Square. The area is dominated by cars and parking provision.

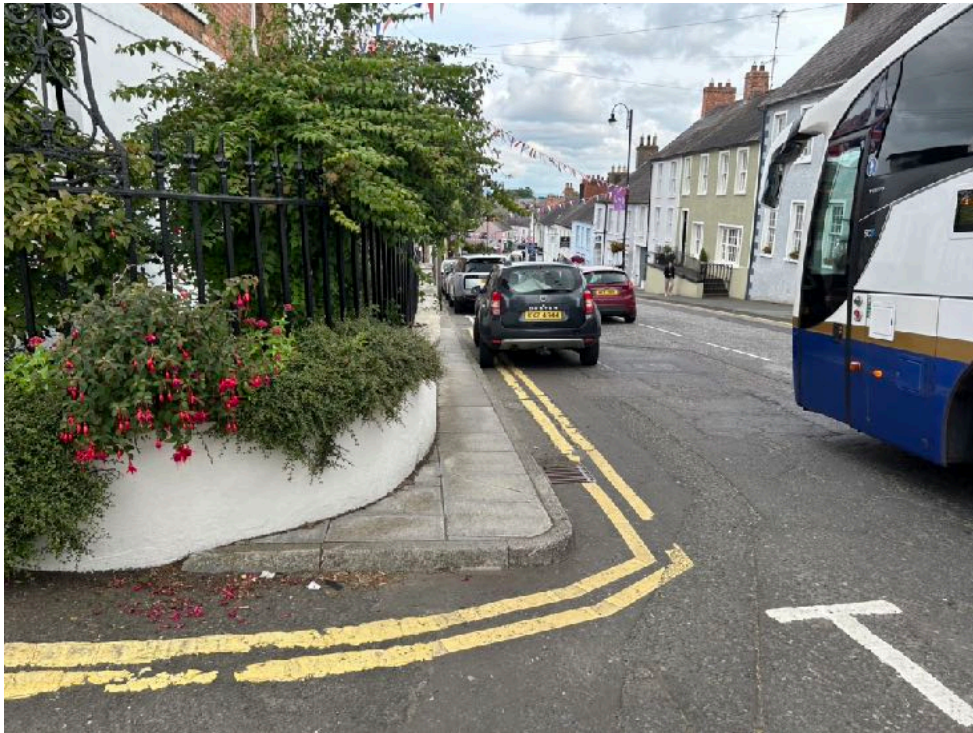
Access at the western side of the top of Main Street is particularly difficult with a very narrow kerbed footway, unusable to many.

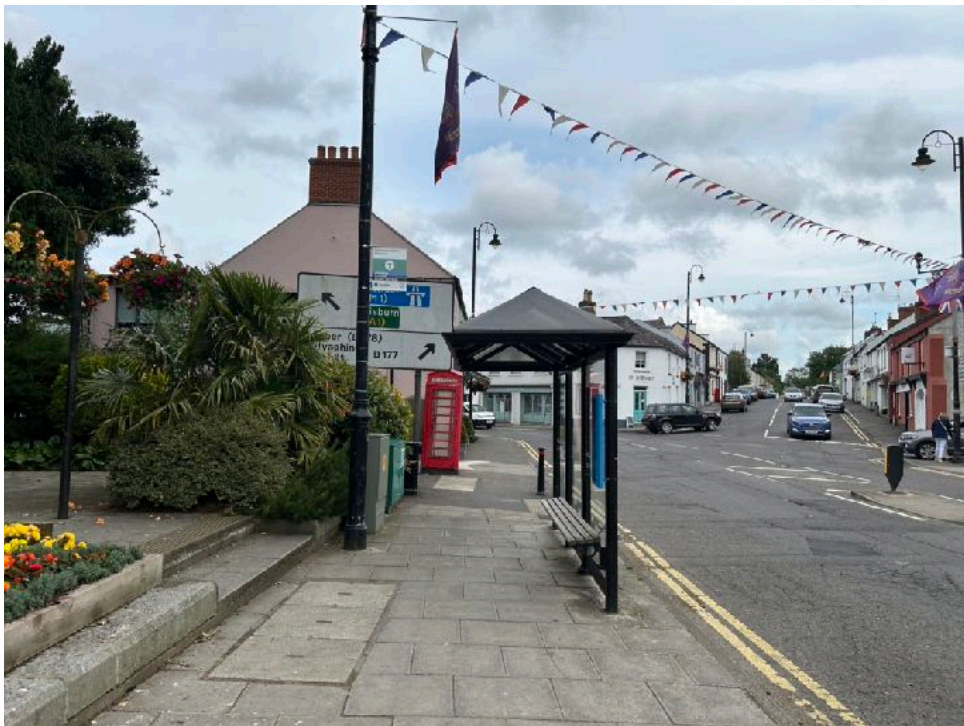
At the bottom of Main Street on the western side, there is a bus stop with shelter and a public space with seating. Buses have priority access to the kerbside.

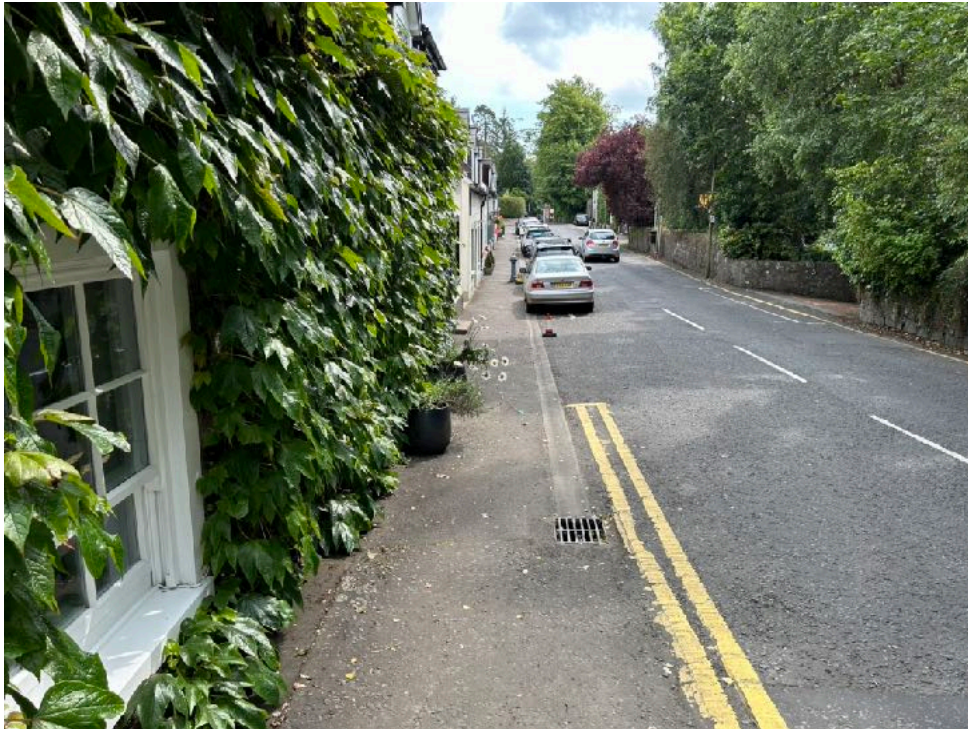
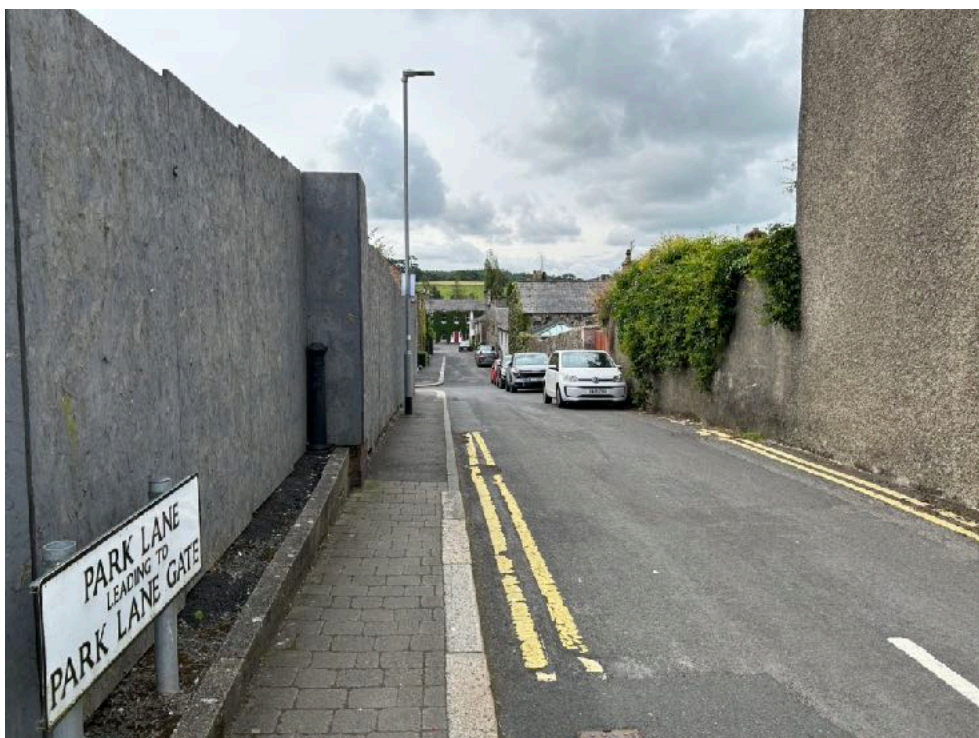
Park Lane and Park Street are both narrow streets with limited discontinuous footway provision on Park Lane and no dedicated provision on Park Street. This means that on both streets, pedestrians in the main are forced to share space with vehicles.
