Comments from Imtac about proposals for a public realm scheme in Hillsborough village

(December 2024)

This report has been written following a request from Lisburn & Castlereagh City Council to review proposals for a public realm scheme in Hillsborough village. The report covers parts of Ballynahinch Street, Lisburn Street and Dromore Street as well as the entirety of Main Street, Park Lane and Park Street.

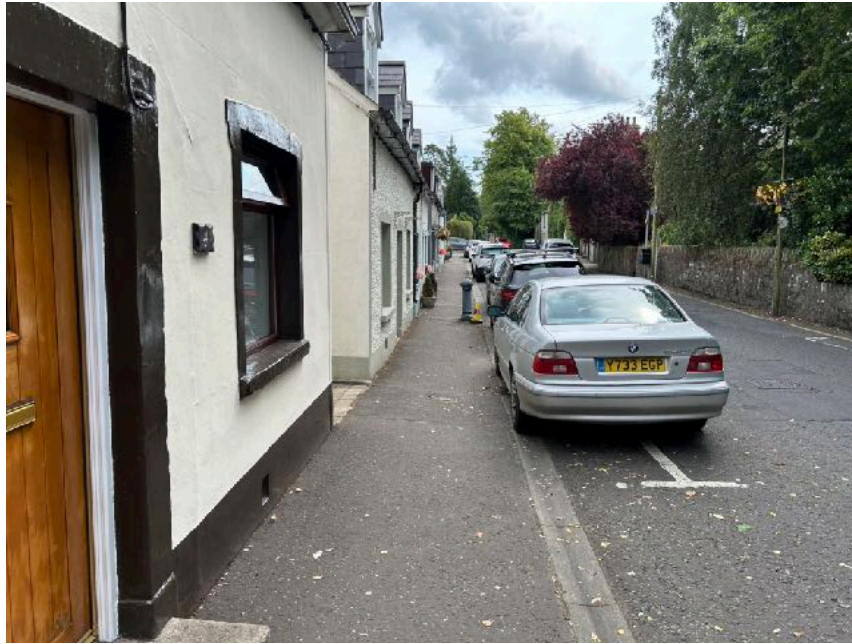
Parking is present on both streets and given that Park Street is the main entrance point to the Forest Car Park, it is heavily trafficked making it a hazardous pedestrian route.

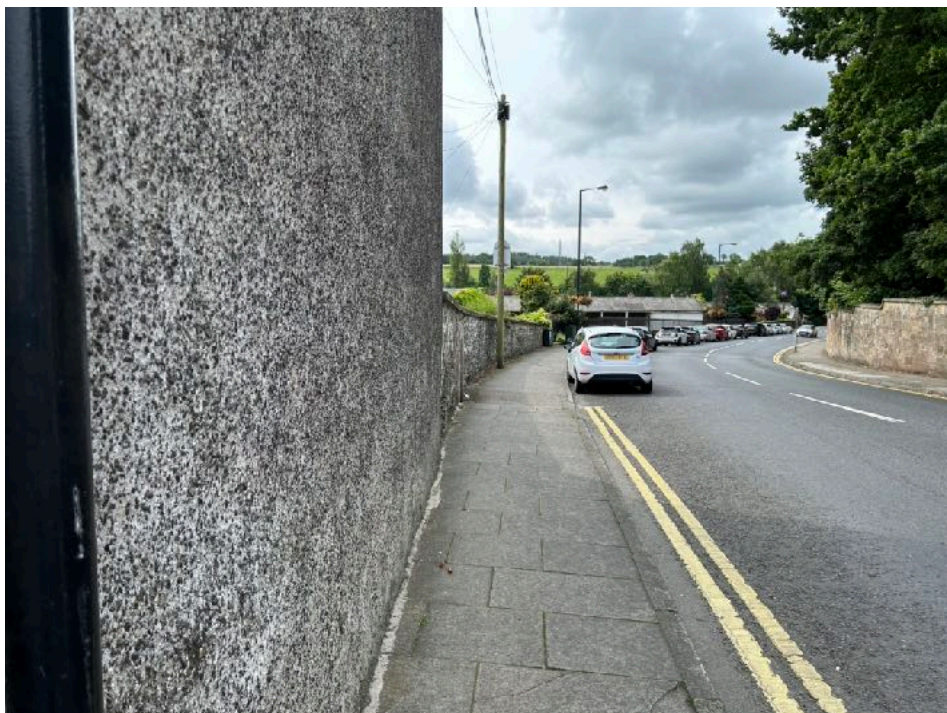
The footways on Dromore Street are relatively broad and uncluttered on both sides.

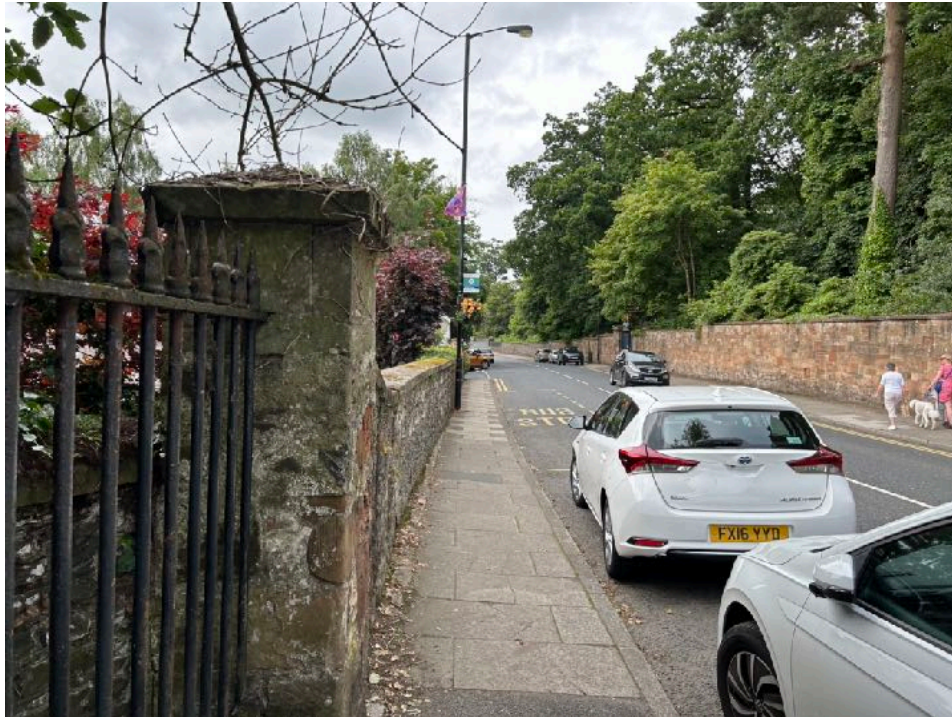
There is on street parking on the eastern side of the street and a bus stop with a bus cage to ensure access to the kerb.

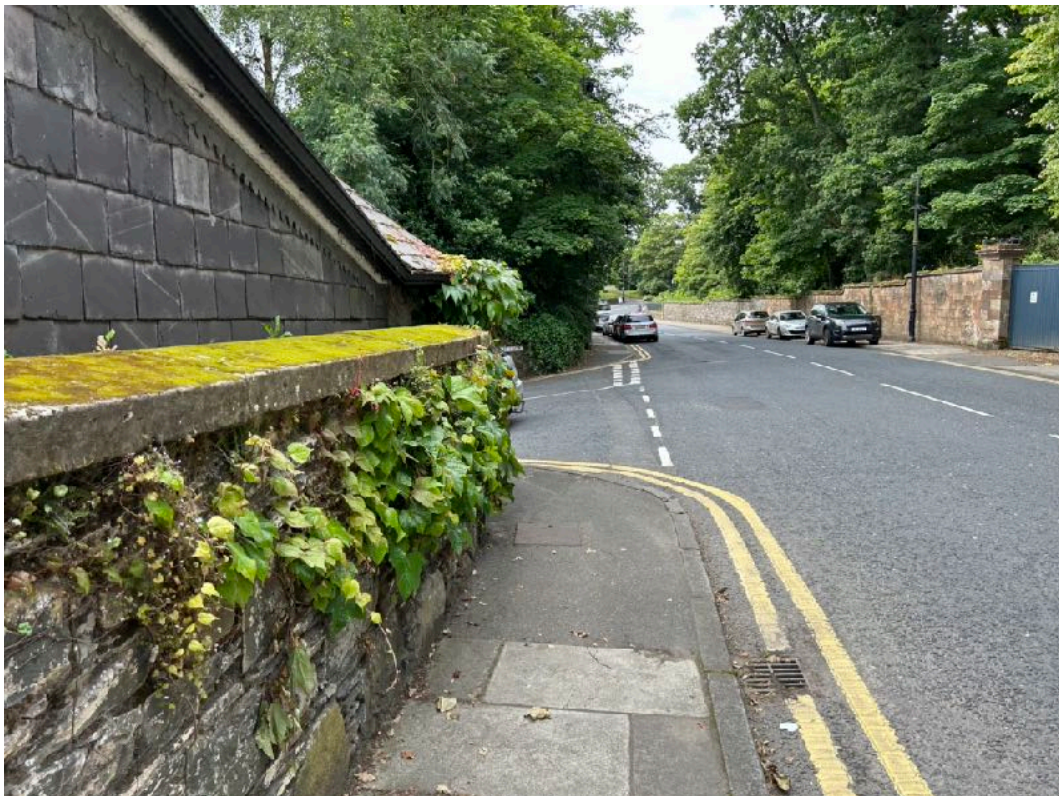
There is an uncontrolled crossing across the junction with Park Street. This crossing does not meet design standards.

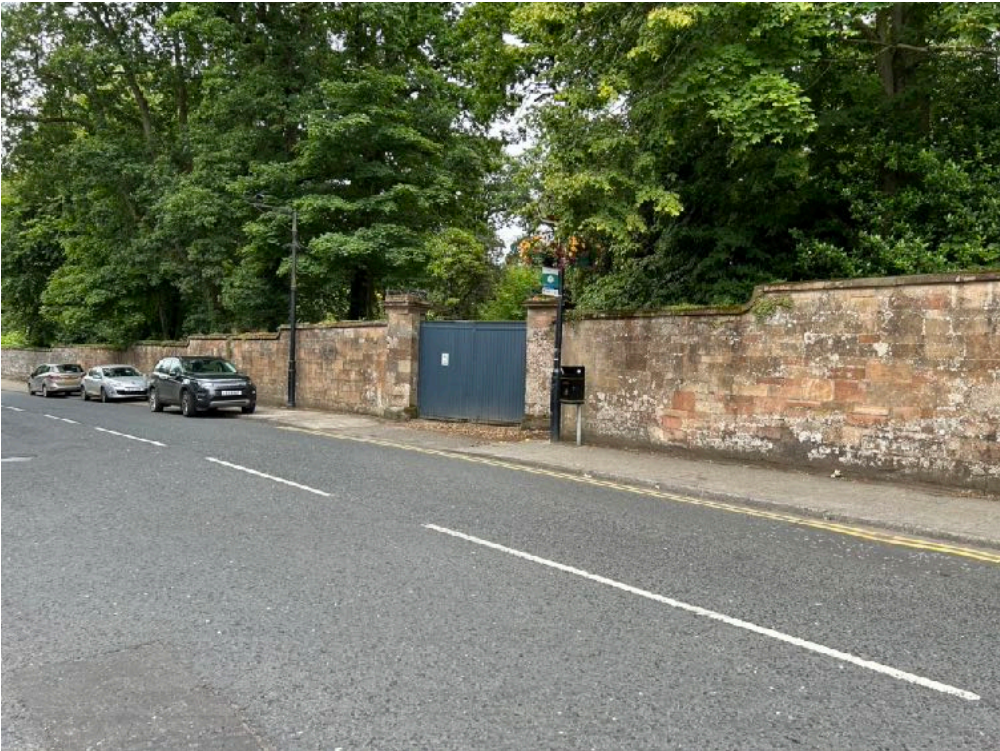
There is a bus stop opposite Park Lane with no accessible provision to safely cross the carriageway.
